Palouse

SCENIC BYWAY APPLICATION VISUAL ANALYSIS DISCIPLINE REPORT

October 2002

**Washington State
Department of Transportation**

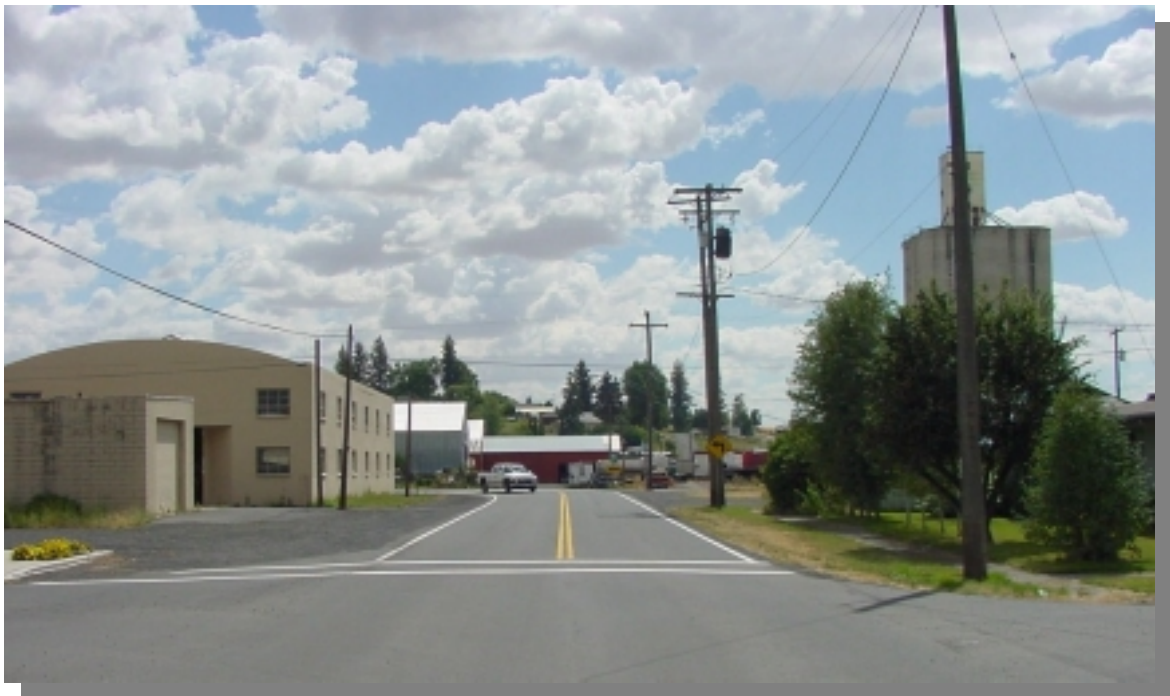
Figure 1 SR 97 and SR 215 Intersection, MP 293.17

For cumulative ratings, cut-off scores for “non scenic” or “scenic” thresholds were determined by comparing scores for two separate locations side by side – one considered “not scenic” and one “scenic.” This method was repeated five times to determine the scenic threshold. Figure 1 shows the intersection of SR 27 as it turns east in Garfield. This warehouse-type development is not considered “scenic.”

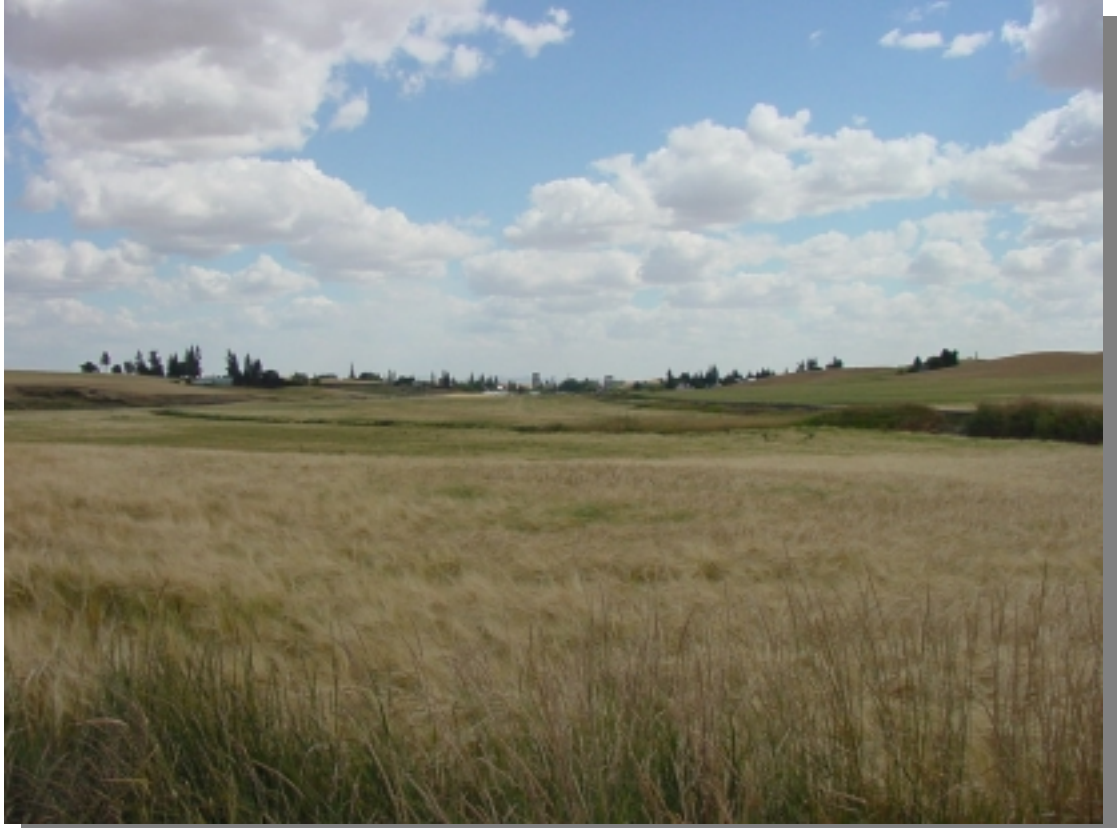
Figure 2 Intersection of SR 27 and SR 271 north of Oakesdale

In contrast, Figure 2 shows a “highly scenic” view just north of Oakesdale and approximately thirteen miles south of the photo above.

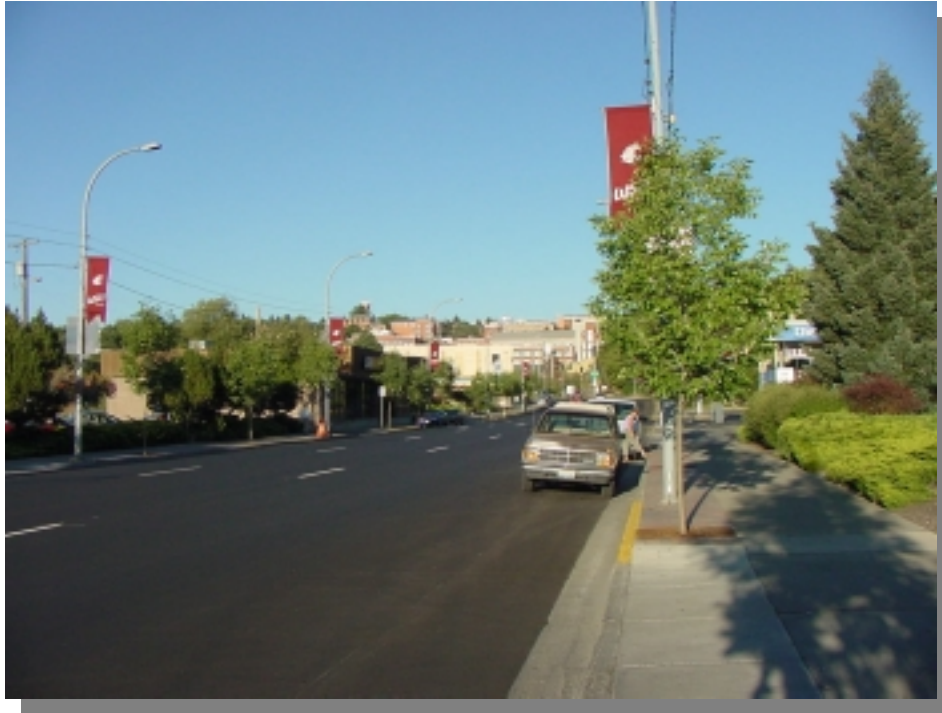
Figure 4 Downtown Pullman and view toward WSU campus

Within the town of Pullman, the same comparison was made to determine thresholds by comparing two urban views. The Washington State University campus can be seen from downtown. This section of the city has flower baskets hanging from light posts, banners, and street trees, which make it a very attractive downtown.

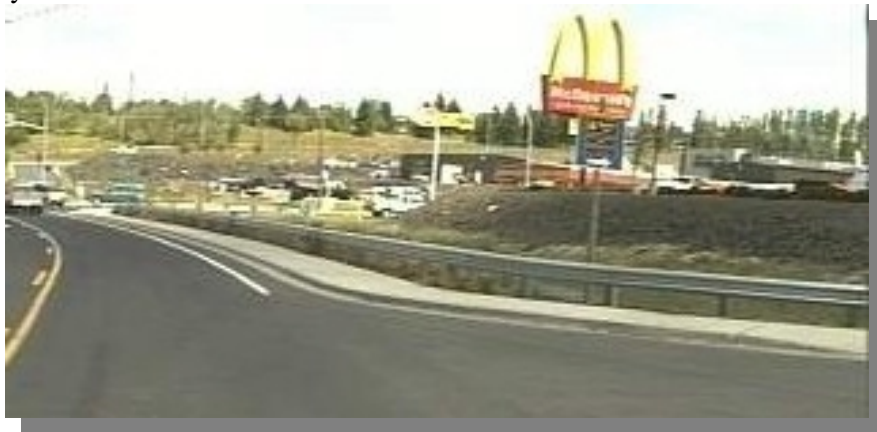
Figure 5 SR 27 in Pullman, MP 1.21

Comparatively, a shopping center with large, a non-landscaped parking lot marks the southern entry into the city on SR 27. Its visual quality ratings are much lower. Figure 5 shows an intersection near the southern entry into town.

As seen in Figure 5, the location at MP 1.21 has a cumulative score of 15. The more scenic location downtown has a rating of 26. The threshold cumulative score for the boundary between “scenic” and “not scenic” for this study is 20.

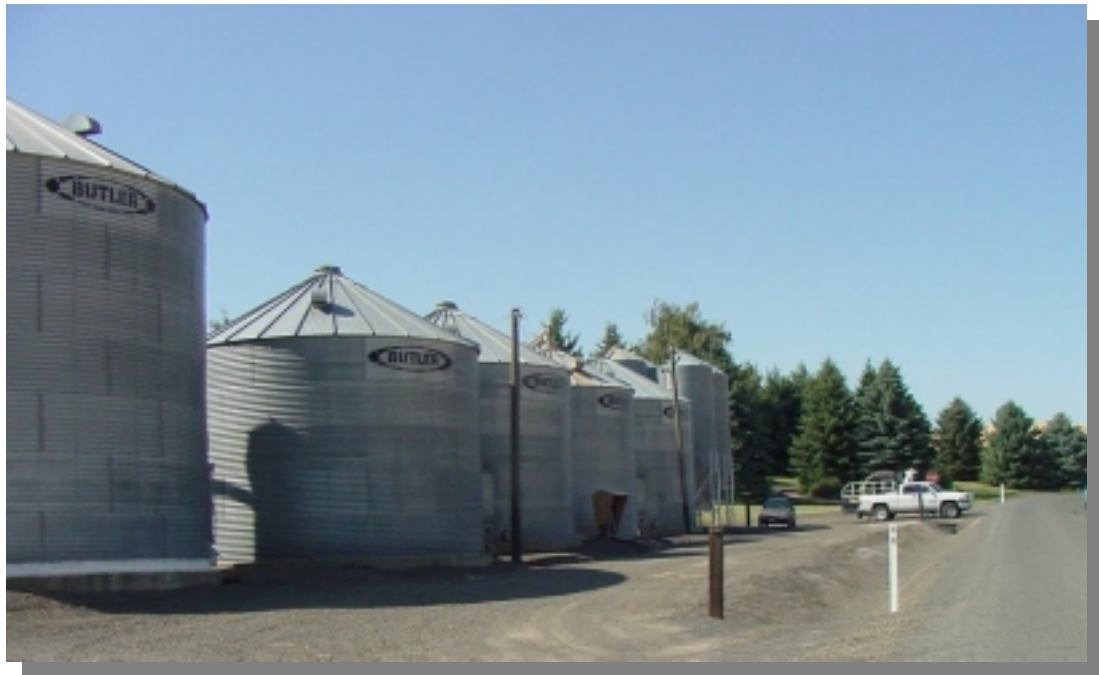
Figure 6 Grain silos adjacent to the road

Along the Palouse’s highway grain silos can be seen adjacent to the road. An example can be seen in Figure 6.

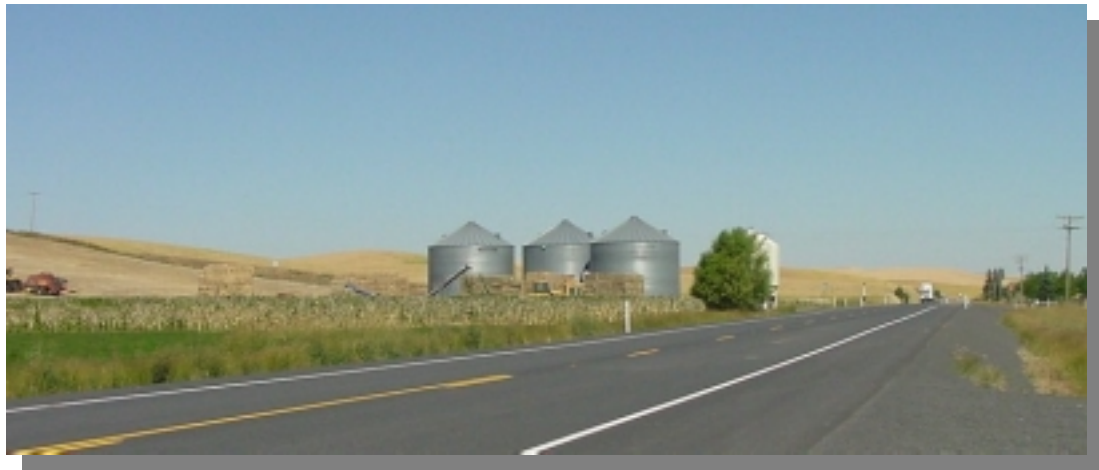
Figure 7 Grain silos with setback and screening.

Where they are set back, they do not encroach on the view to the same degree. With the setback, these silos blend into the landscape and have a higher visual quality rating. An example can be seen in Figure 7.

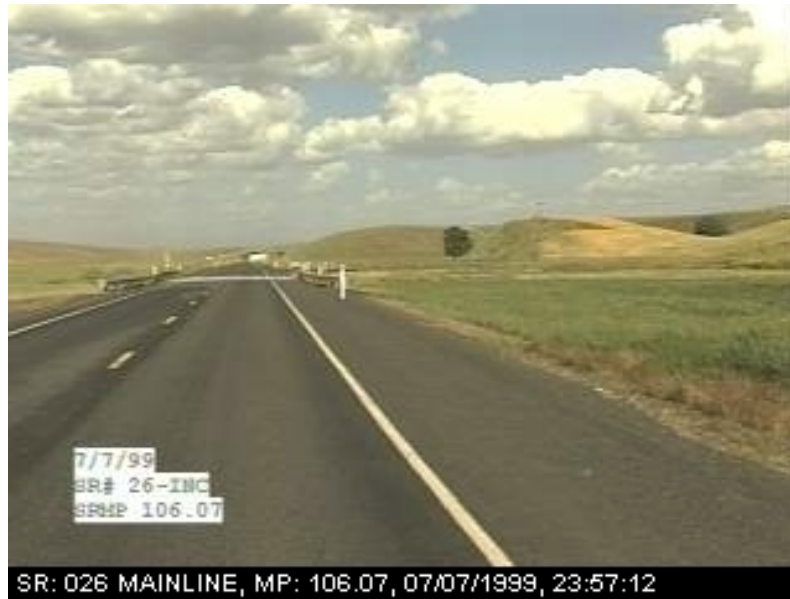
Figure 11 Topography in Landscape Unit 1

Landscape Unit 1 runs from the Whitman County line at the Palouse River (MP 96.88) on SR 26 to the junction with SR 195 in Colfax. The towns of LaCrosse and Dusty lie adjacent to SR 26 within this landscape unit. Gently rolling hills characterize this landscape unit.

The hills can be seen in Figure 11. Figure 12 shows the percentage in each scenic classification for Landscape Unit 1 Eastbound. Over 99% of this corridor is rated “scenic” or greater.

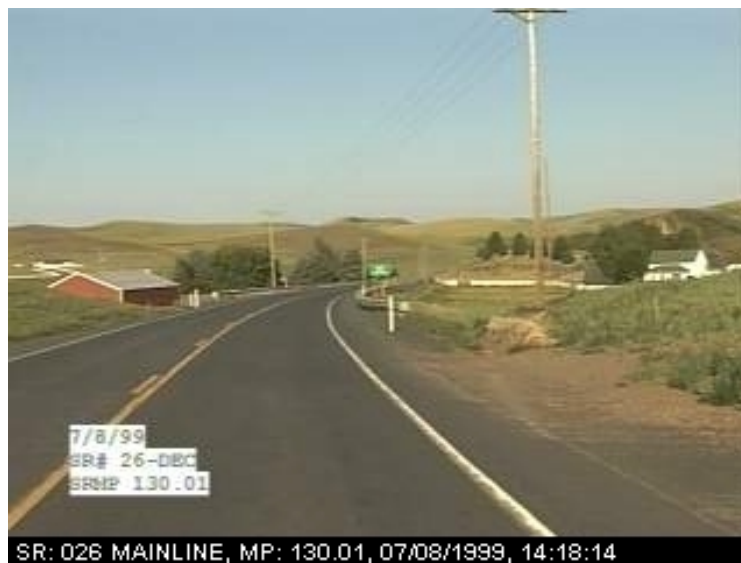
Figure 14 SR 26 Westbound - west of Colfax

Landscape Unit 1 Westbound begins in Colfax at the junction of SR 26 and SR 195 in an industrial area. When traveling westbound, views of machinery stockpiles and industrial buildings are more apparent than when seen from the eastbound lanes. The highway travels through the outskirts of town before reaching open fields. Figure 14 shows the transition zone between Colfax and open fields.

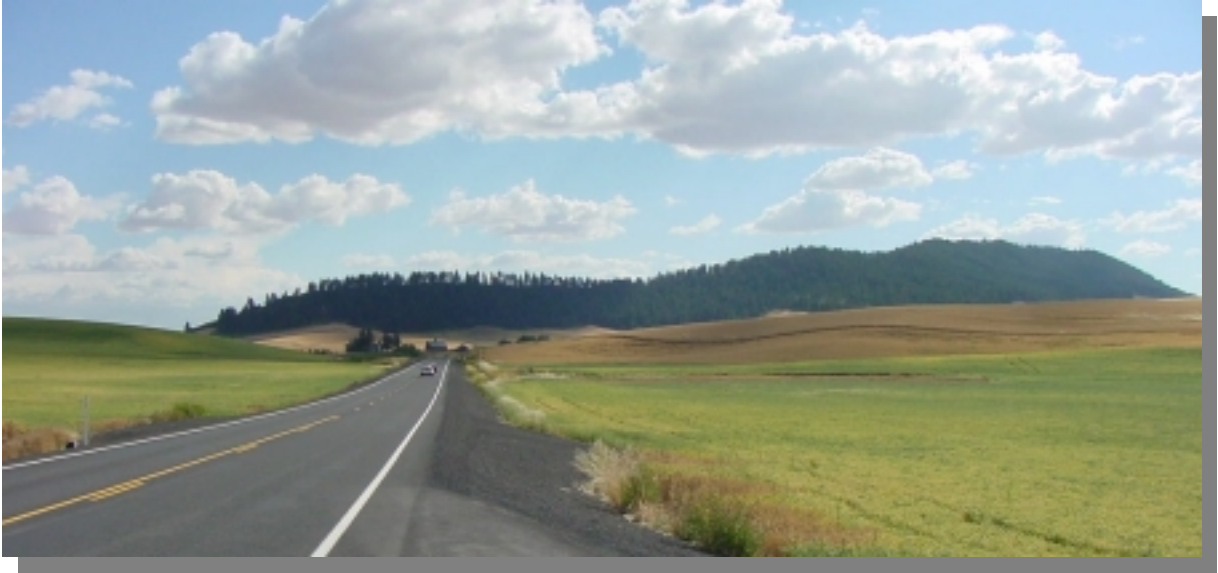
Figure 24 Landscape Unit 3, view southbound toward Kamiak Butte at MP 12

The road southbound curves toward Kamiak Butte in a long downward slope. This allows a long dramatic view of the butte as seen in Figure 24.

The visual quality ratings are higher from this direction of travel. Water is more apparent near Pullman and views of Kamiak Butte are dramatic. Figure 23 shows the scenic classification percentages for this landscape unit.

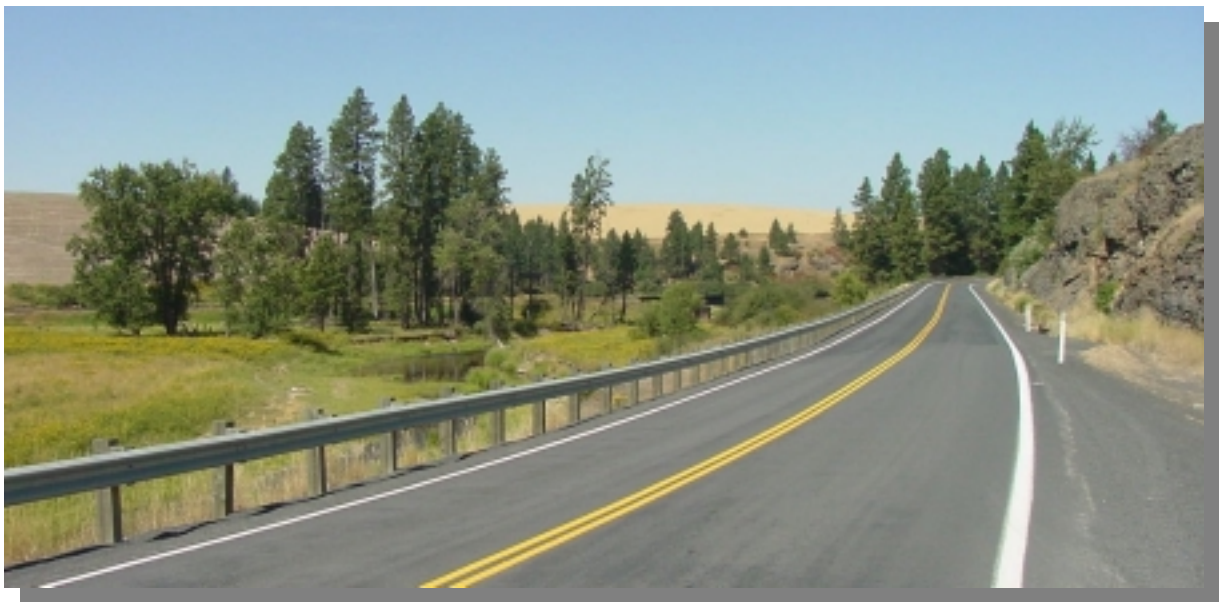
Figure 27 Topography of Landscape Unit 4. View Northbound at MP 19.22

Landscape Unit 4 Northbound runs from downtown Palouse to the junction of SR 27 and SR 271 just north of Oakesdale. SR 27 follows the Palouse River north of the town of Palouse. The views of the river raise the visual quality ratings here. Basalt rock formations also raise the landform ratings at this location. Figure 27 is a view at MP 19.22.

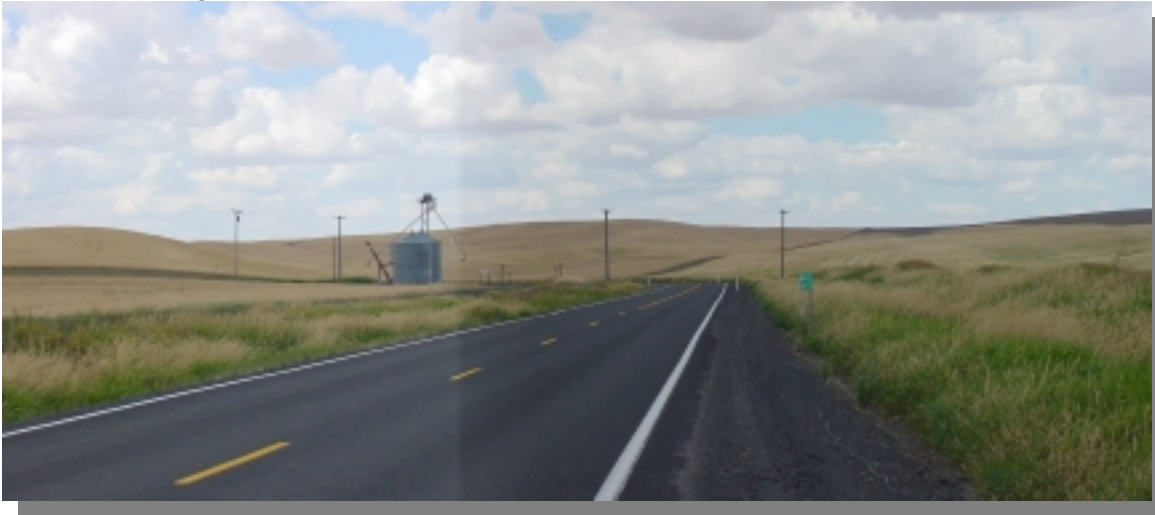
Figure 43 SR 271 northbound at MP 1.934

This northbound landscape unit runs from north of Oakesdale to south of Rosalia at the intersection with SR 195. Figure 43 shows the view from MP 2 northbound.

The silos in Figure 43 are set back from the road. This placement increases the visual quality from the perspective of the road. All views from the northbound lanes are “scenic” or greater. Most views are “highly scenic.” This can be seen in Figure 44.

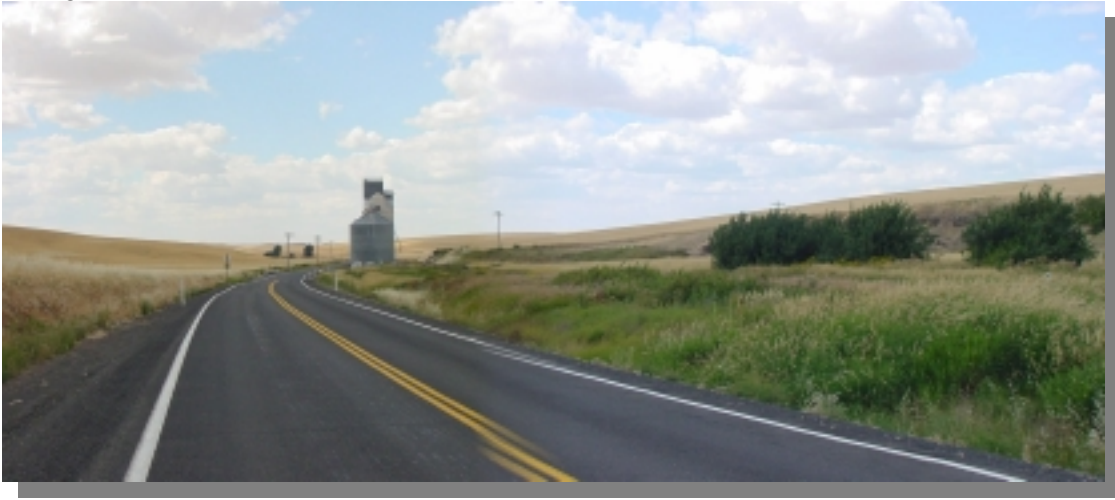
Figure 46 View southbound on SR 271 at MP 4.87

The southbound direction of travel is toward Oakesdale. One hundred percent of the views are “scenic” or greater. Figure 46 shows the view at MP 4.87 of a grain elevator and silos that are seen throughout the area.

Railroad lines run along this route and the bench can be seen to the right of the shrubs in the photo. Figure 47 shows the percentages in each scenic classification on this route from the southbound lanes of travel.

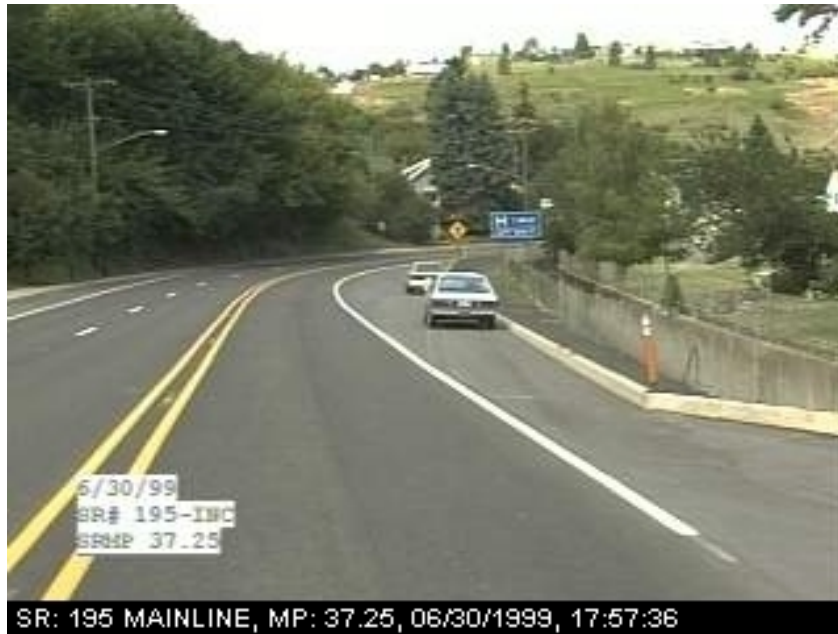
Figure 60 Southern entry into Colfax, within city limits

Landscape Unit 10 covers views from the roadway between Pullman and Colfax. Just under 79% of this landscape unit is classified as “scenic” or greater. Figure 60 shows the southern entry into Colfax with a section of the concreted-lined river channel to the right behind a chain-link fence.

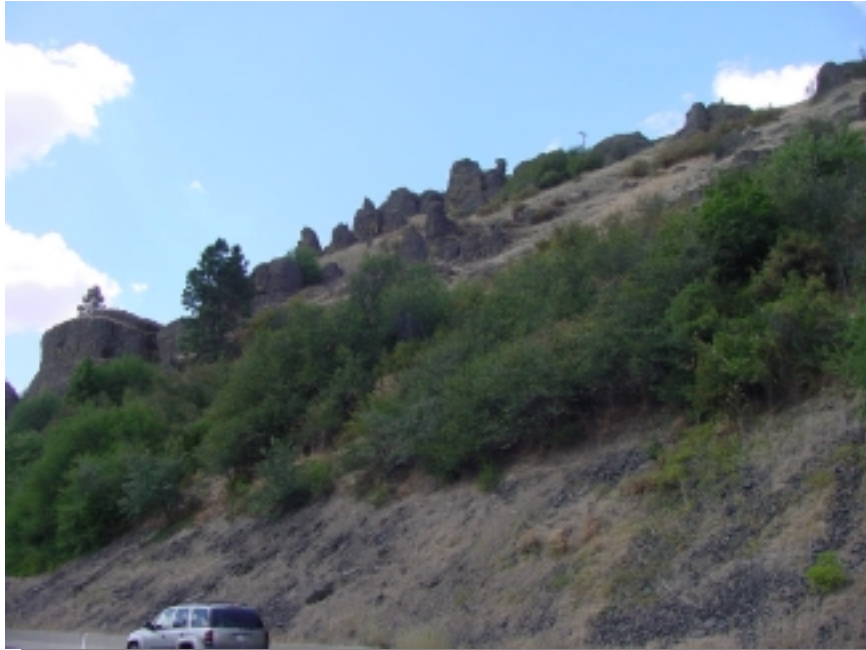
Figure 70 Rock formations above southern entry into Colfax

The entry into Colfax from southbound SR 195 reveals very interesting rock formations above the road. This raises the landform rating in this location. These rocks can be seen in Figure 70.

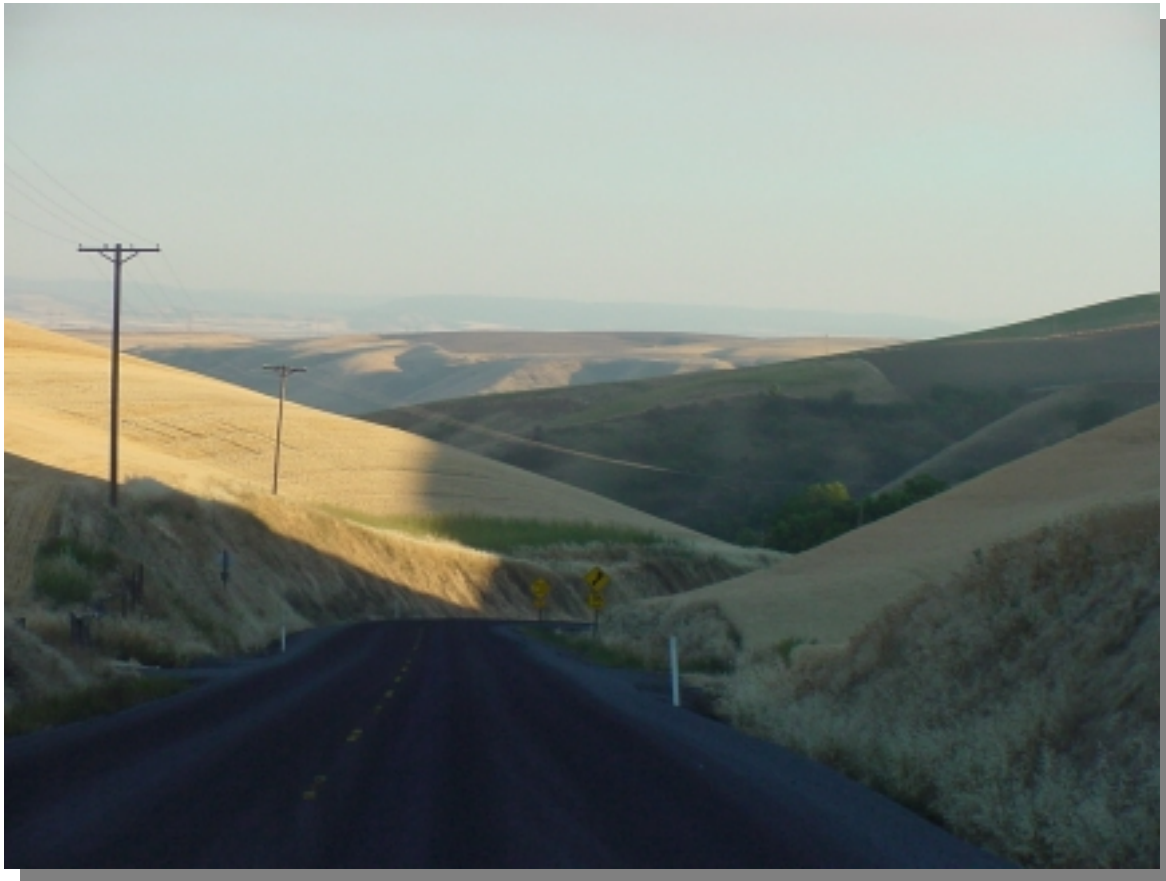
Figure 85 View southbound on SR 194 from MP 4.374.

The road travels through a rural and open landscape. As the road nears the Snake River, the topography becomes more dramatic – the hills loom larger. Once the canyon of the Snake comes into view, the landform ratings rise to 6.

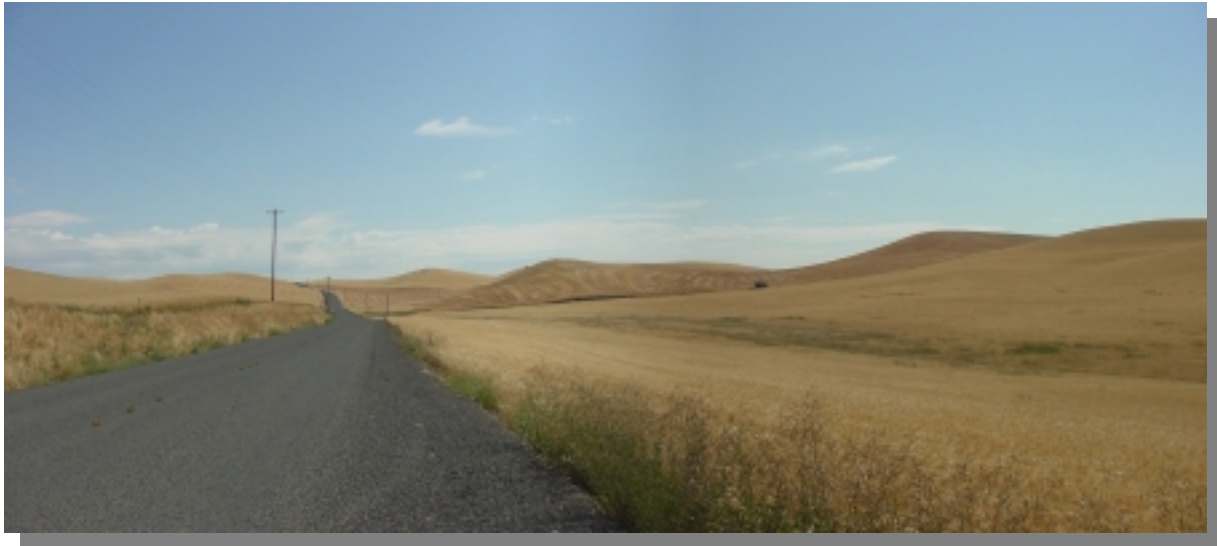
Figure 90 View eastbound from MP 1.88 on SR 272

Views eastbound on SR 272 are typical for this region as seen in the photo above.

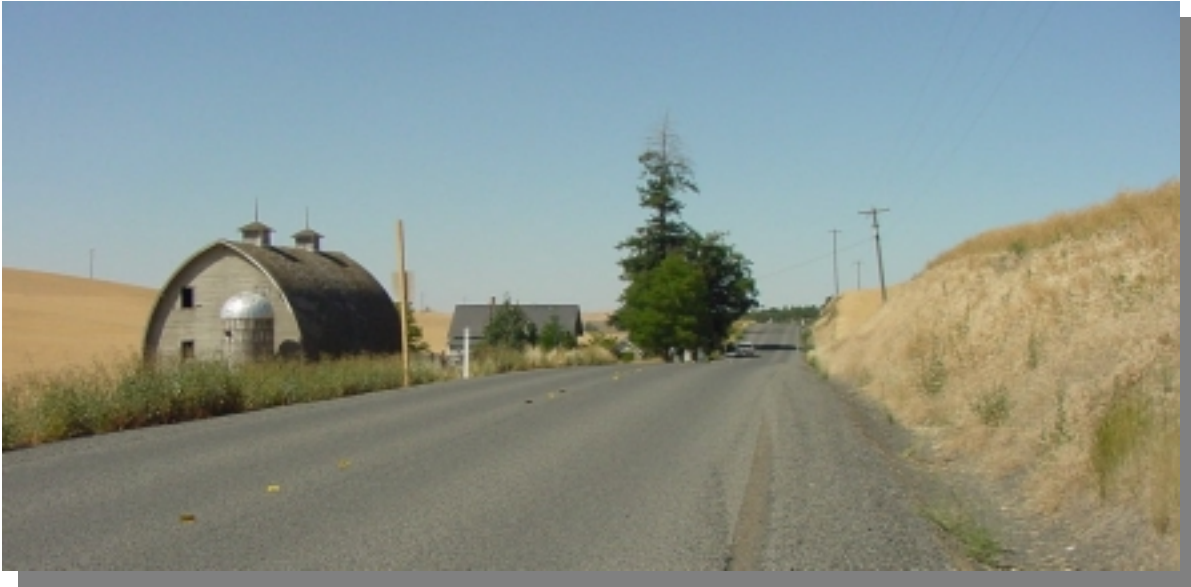
Figure 94 View of barn at MP 1.88 looking westbound

Figure 94 is an example of an “exceptionally scenic” view within this landscape unit.

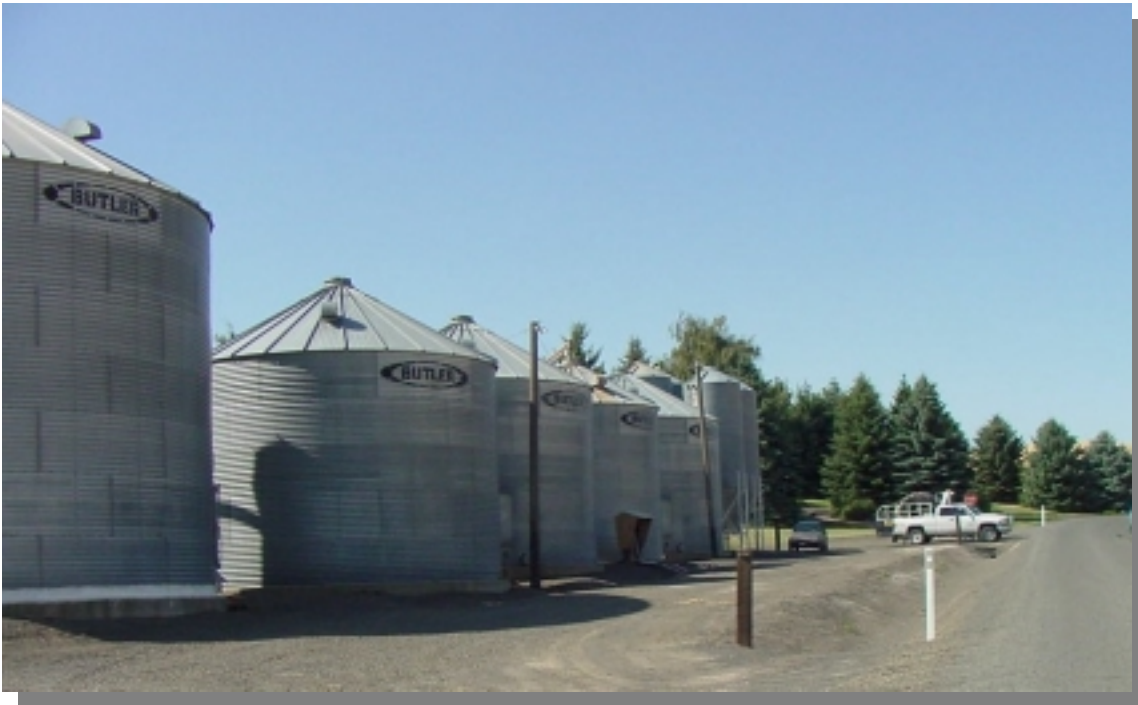
Figure 95 View westbound at ARM 11.246 of grain silos

Figure 95 is an example of grain silos directly adjacent to the roadway that has a high degree of human impact that lowers the human, intactness, and unity scores.

This disruption in the scenic quality is brief and in context with adjacent agricultural land uses. Figure 96 shows the breakdown of percentages in each scenic classification.
